CANAAN STREET LAKE

Canaan Street Lake's Protection Plan

John Bergeron Dave Shinnlinger Town of Canaan Source Water Protection Committee

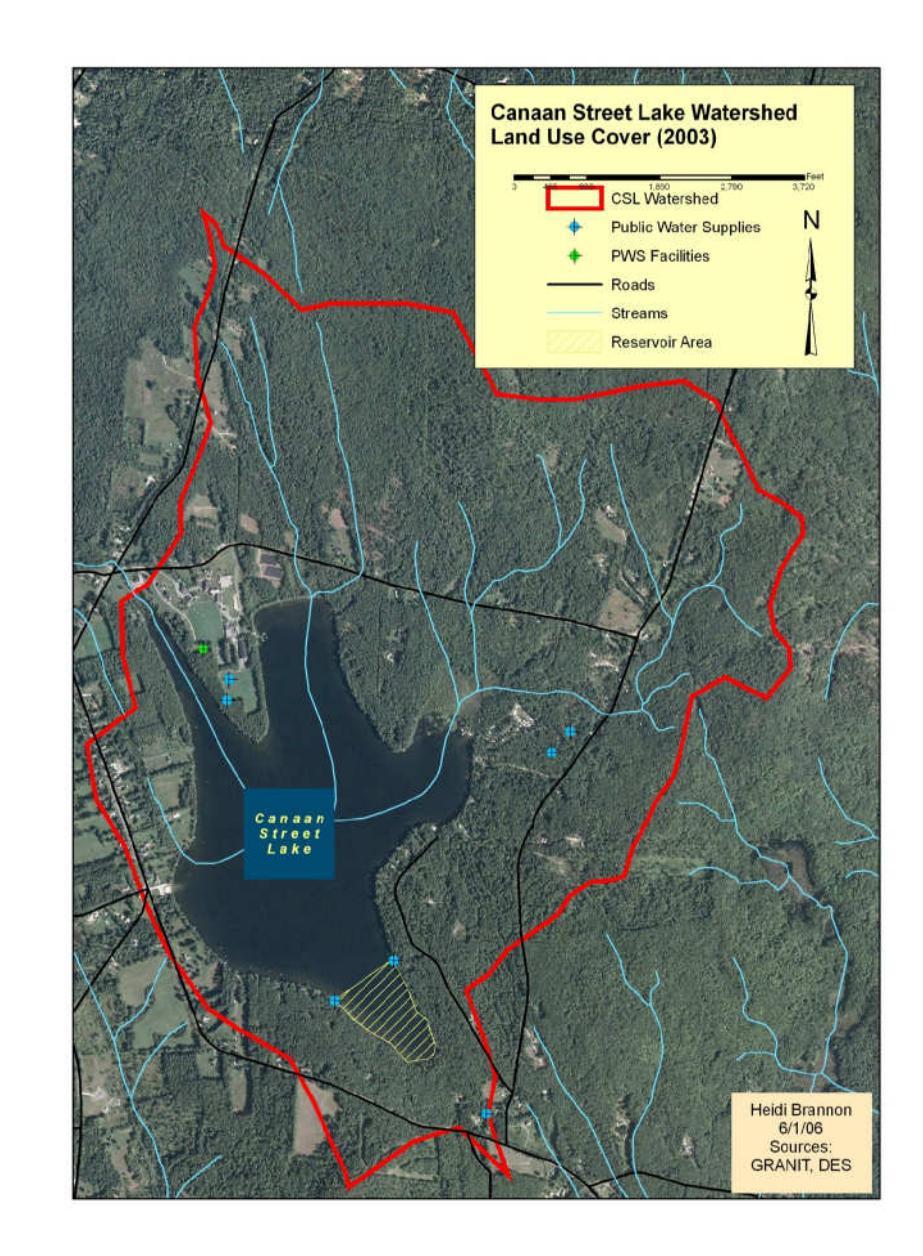
Canaan St. Lake Watershed

The Canaan Street Lake watershed is defined as the area of land and network of wetlands, ponds, and tributaries that drains to Canaan Street Lake.

Public Water Systems

Intake Area

Large amount of forested land

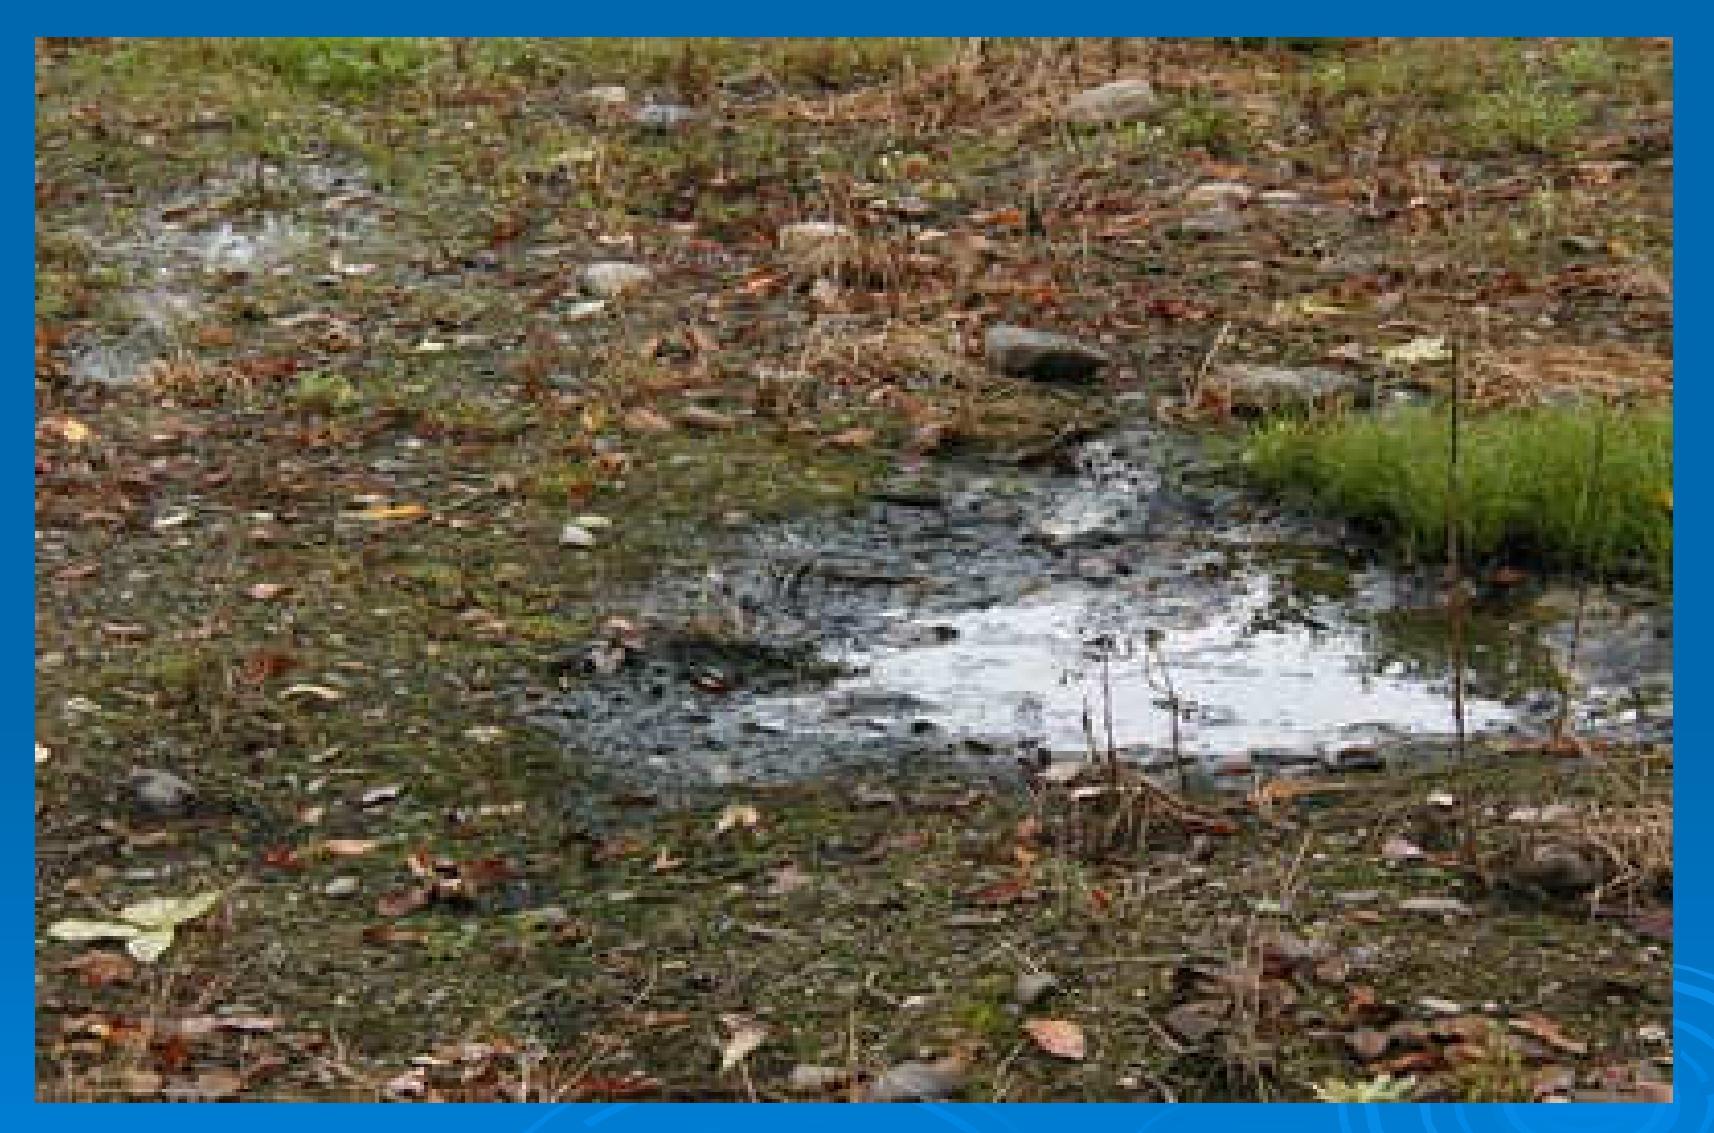
Failed Septic System

This failure not is in Canaan

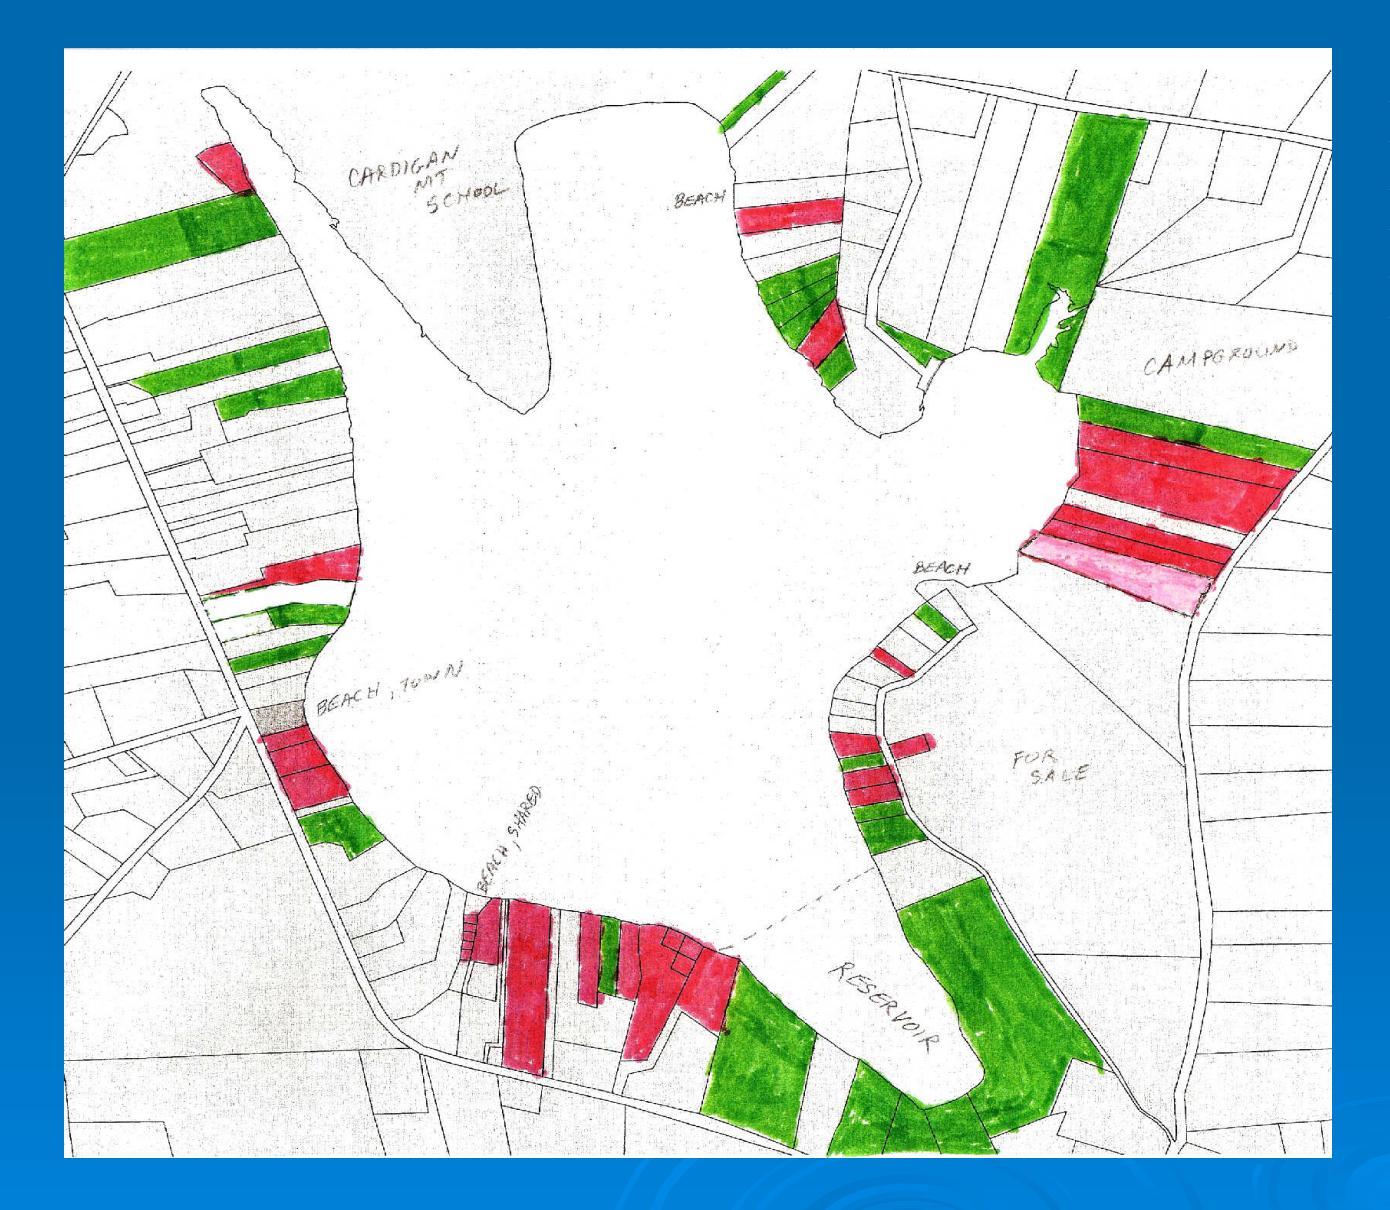
Septic Survey (sample)

Red = older
White = newer
Green = vacant

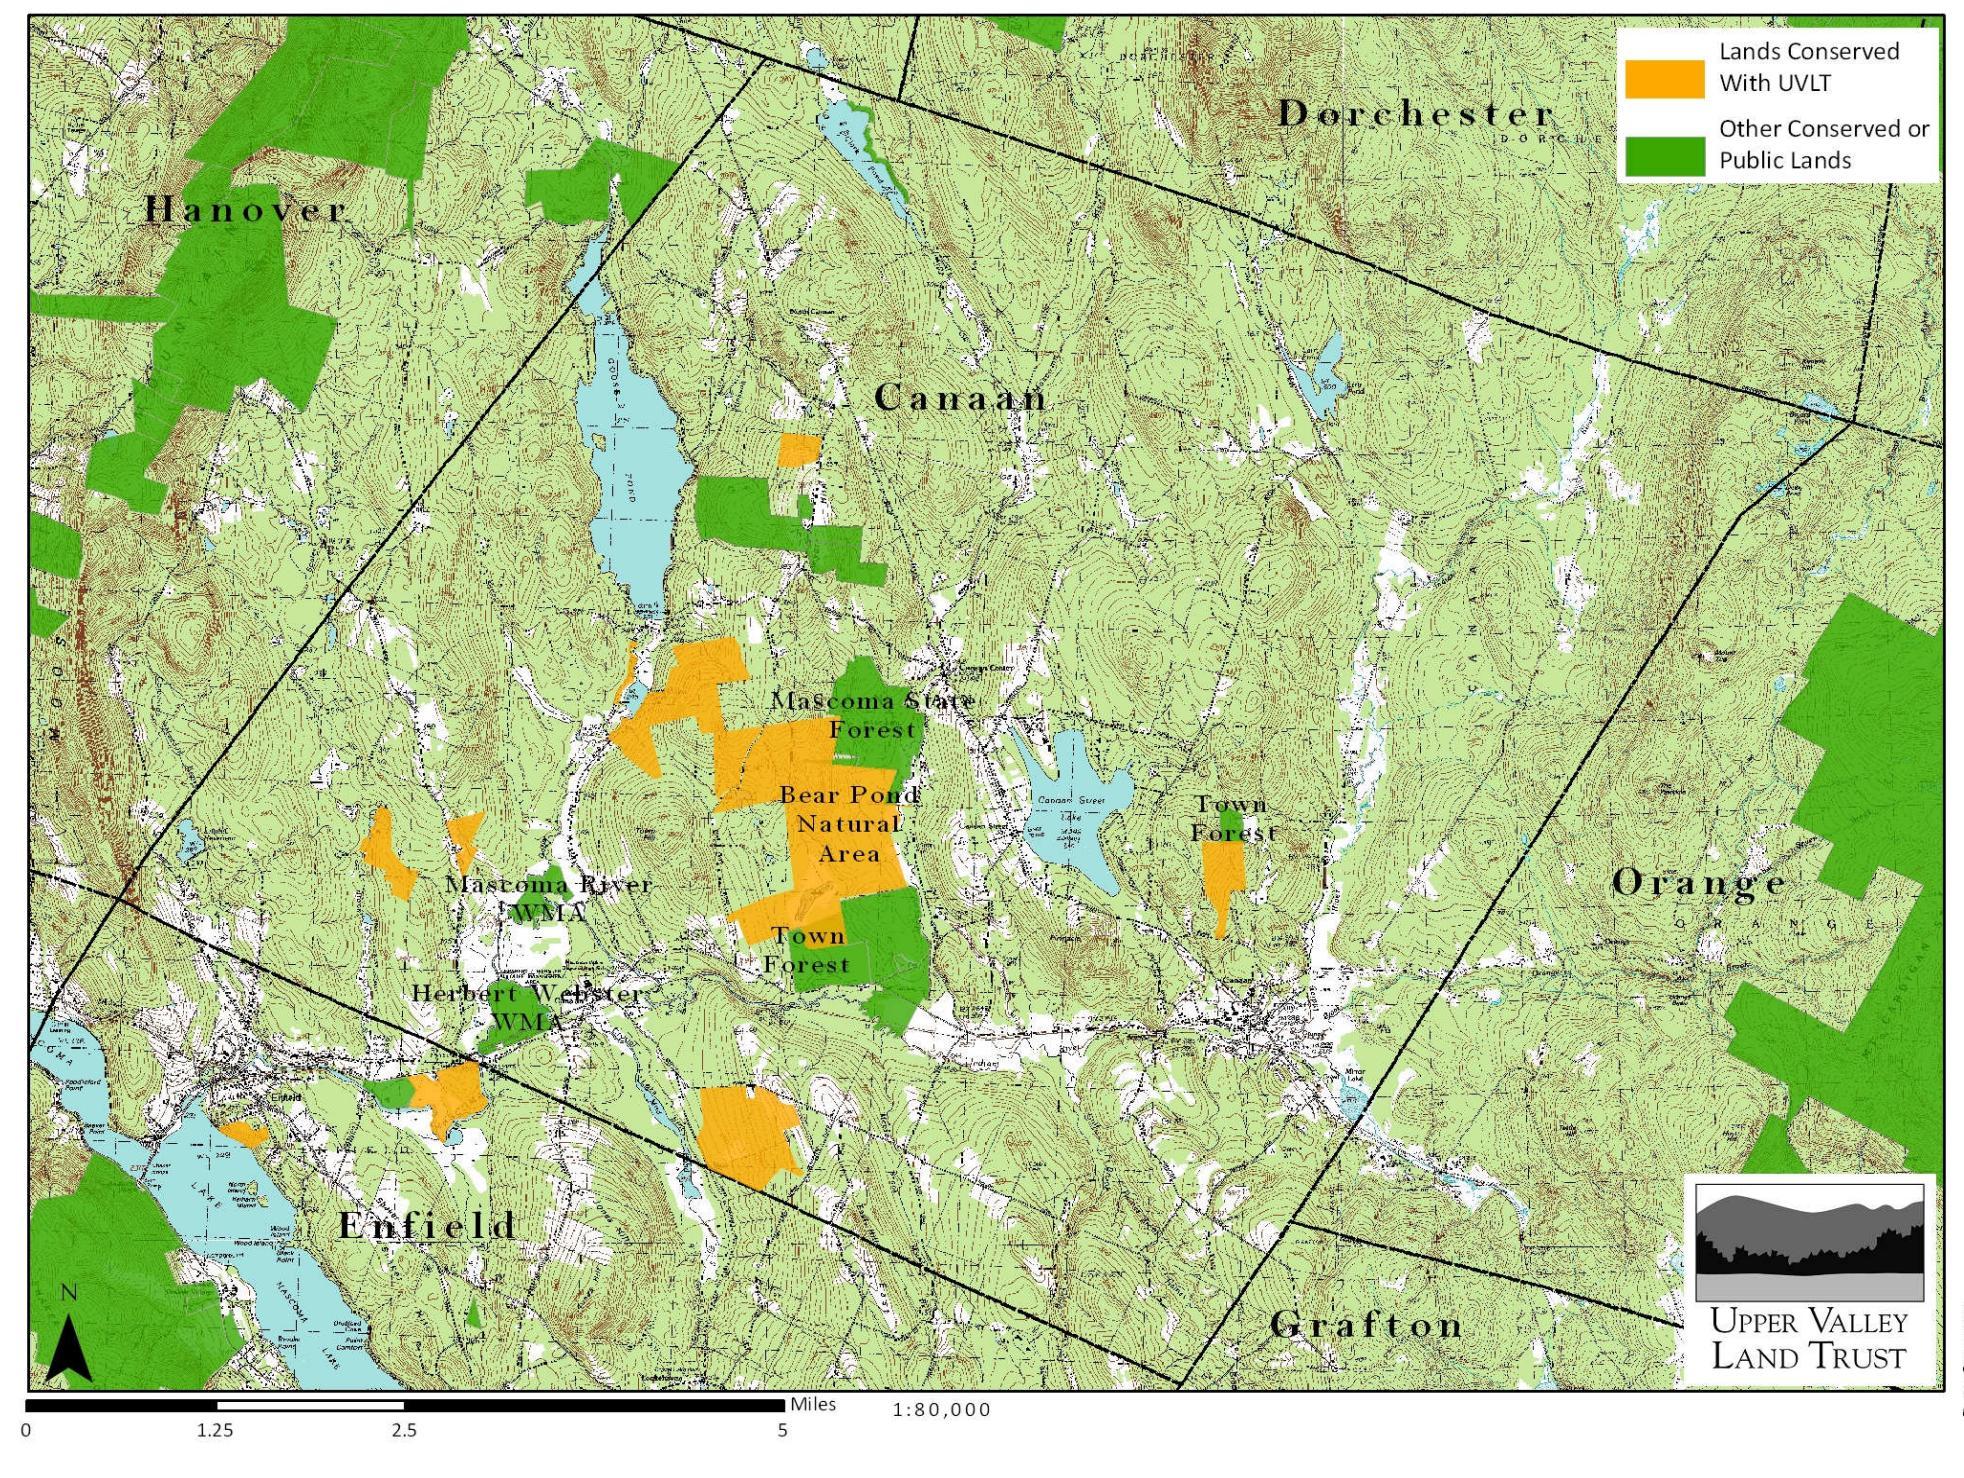
Conserved & Public Lands in and around Canaan, NH

Prepared: August 1, 2008 Other Conserved/protected lands: NH ords, surveys Other Conserved, ArcGIS file: CANAAN.mxd (ALB) records, Data Sources: Topograhic base map: NH GRANIT: DRG tiles 92, 93, 94, 105, 106, 107. UVLT Conserved Lands: UVLT r GRANIT consp layer (2004-08) Town Boundary: NH GRANIT, edited Map Projection: NH SPCS, NAD83,
